# JERSEY CITY RESERVOIR NO.3 DAM

## PHASE I INSPECTION REPORT NATIONAL DAM SAFETY PROGRAM

NJ 00524

JERSEY CITY RESERVOIR NO. 3 DAM (NJ00524)

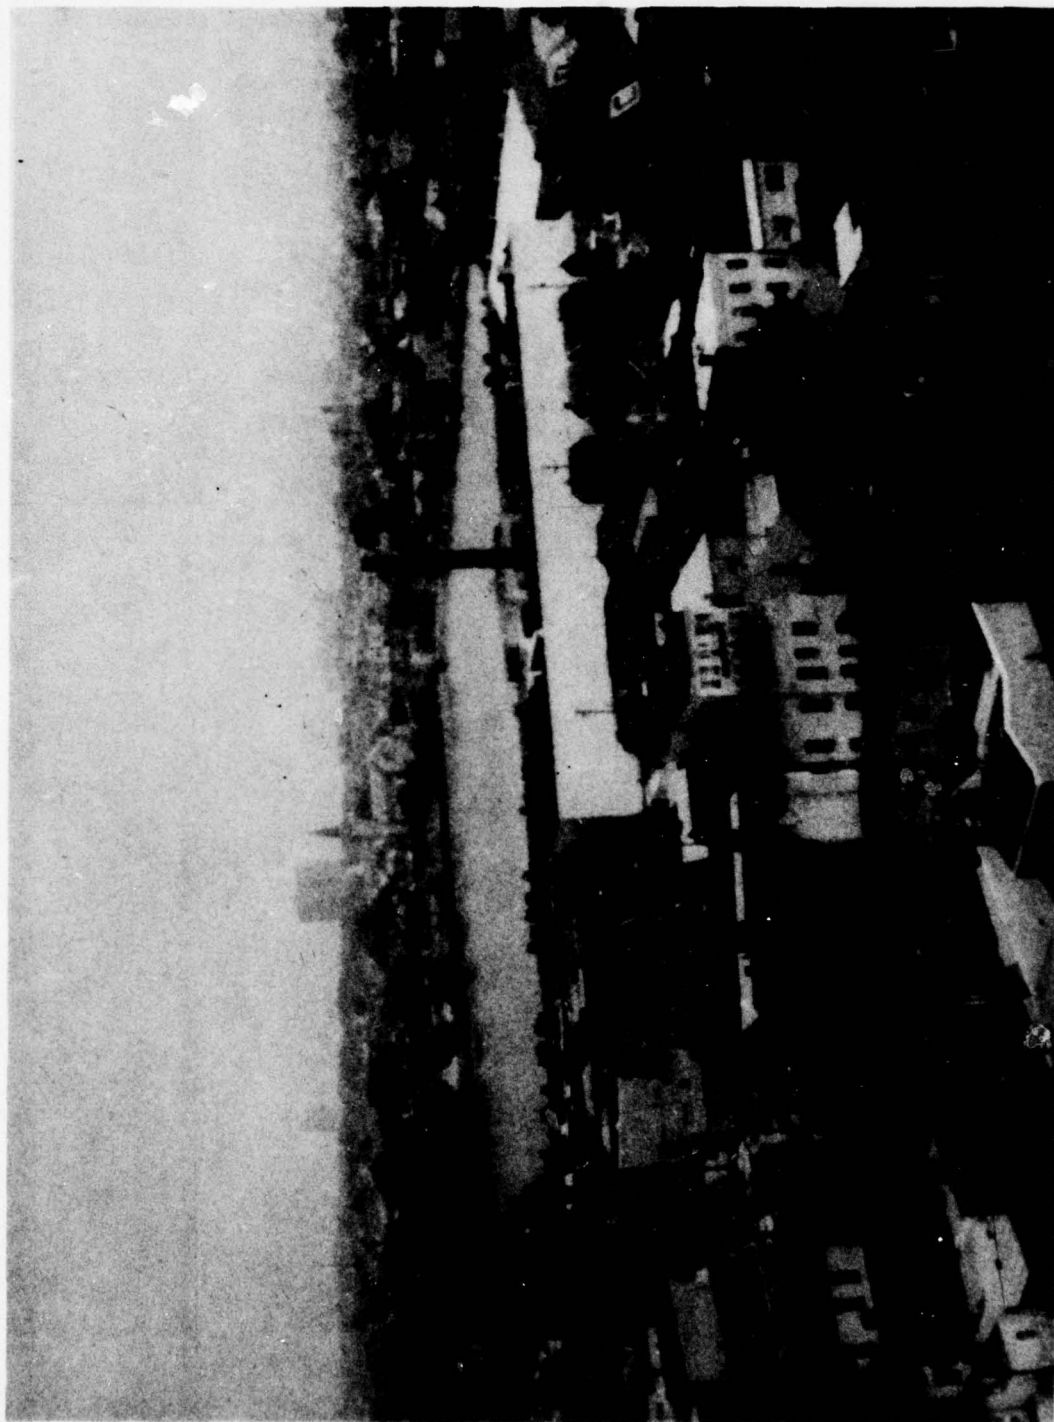
OVERVIEW OF JERSEY CITY RESERVOIR # 3

Jersey City Reservoir No. 3 appears to be in a stable but questionable condition and is in need of wall repair. Escalation of the leak through the west wall could lead to hazardous settlement of the embankment and eventual collapse or breaching of the perimeter walls. Failure could cause significant property damage to surrounding residential areas and result in a major loss of life. Sufficient engineering data was not available to adjudge anything but a questionable assessment and further studies are recommended in the near future.
